Mosul Dam the Full Story: Engineering Problems

Nasrat Adamo¹ and Nadhir Al-Ansari²

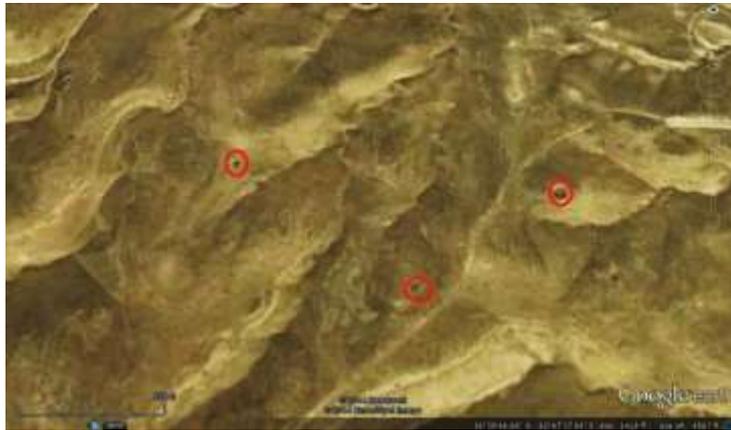
Figure 8: Enlarged Google Earth image showing many sinkholes (Dark spots encircled by red color) in the upstream area of the dam site [3] [4] [5] [6]

1. The karsts prevailing in the dam site and in the reservoir area.
 2. The existence of gypsum/anhydrite rock formations in dam foundation alternating with soft marl layers and weathered and cavernous limestone beddings.
 3. The presence of an extensive ground water aquifer called Wadi Malleh aquifer which affects considerably the ground water regime in the right bank
- Figures (8), shows the extent of the karsts phenomena in the form of sinkholes upstream area of the dam and in the reservoir.

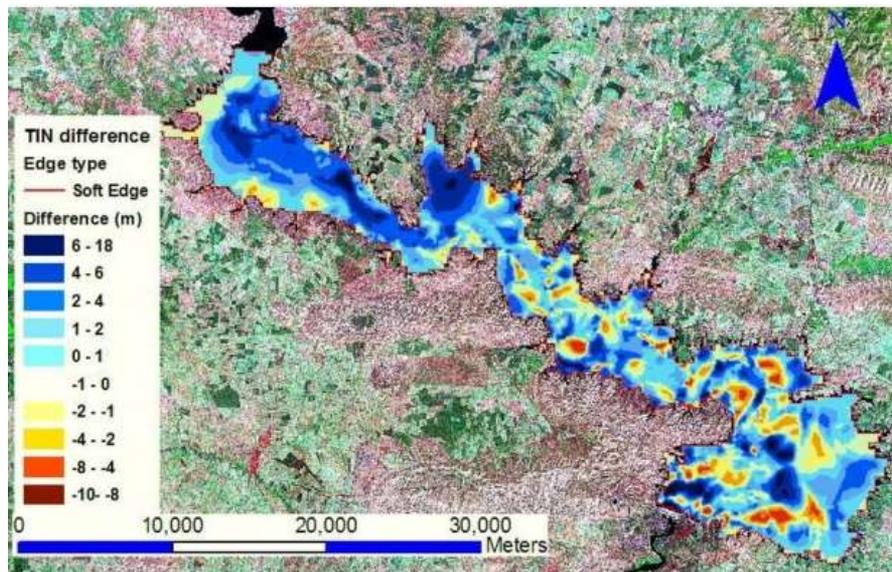
Figure 9: Sinkholes present in the Reservoir [2]

The sinkholes in the reservoir itself shown in figure (9) were mapped by a recent bathymetric survey which was carried out in 2011 by a Luleå university PhD student [2]. It is considered here that the development of such sinkholes will open new connections with the groundwater aquifer running below and around the dam site causing more problems of dissolution and formation of new sinkholes. The dam foundations itself is very complicated and the combination of gypsum/anhydrite layers with the cavernous limestone give rise to very favorable conditions for seepage and dissolution environment. Figure (10) gives a representative picture of this condition.

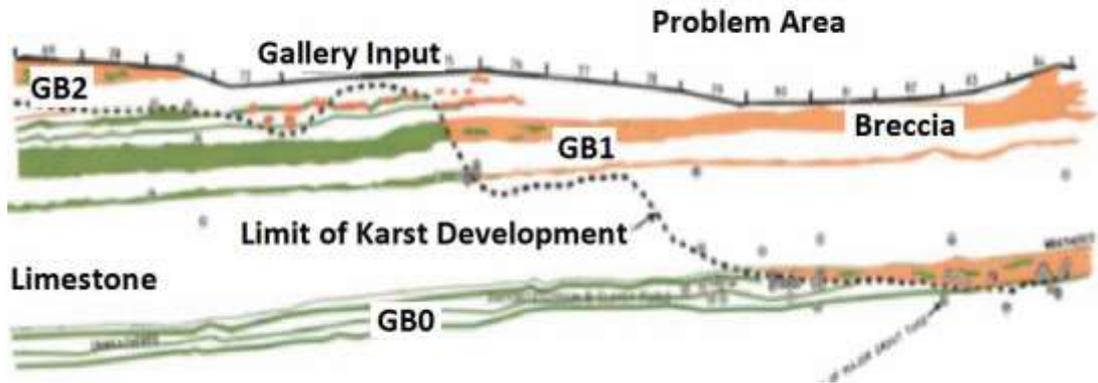
Figure 13: Estimated karsts line in the problem area (sections 69-87).The dark dots show locations of some of the major grout take areas [7].

In figure (13) the dotted line is the estimated karsts line in sections 69-87 which is the problem area as visualized by the designers. This hypothetical karsts

line was estimated from the in situ permeability tests results in the boreholes drilled along the axis of the dam during the investigation. The dark dots on and above and on this karsts line indicate some of the areas of major grout take. Below this line according to these tests and designer's judgment karsts diminishes considerably and cease to exist. These results were used as the defining criterion for fixing the depth of the grout curtain. The design went further to add another 20 meters to this depth for ensuring the cutting out of any seepage path that might have been missed in these permeability testing.

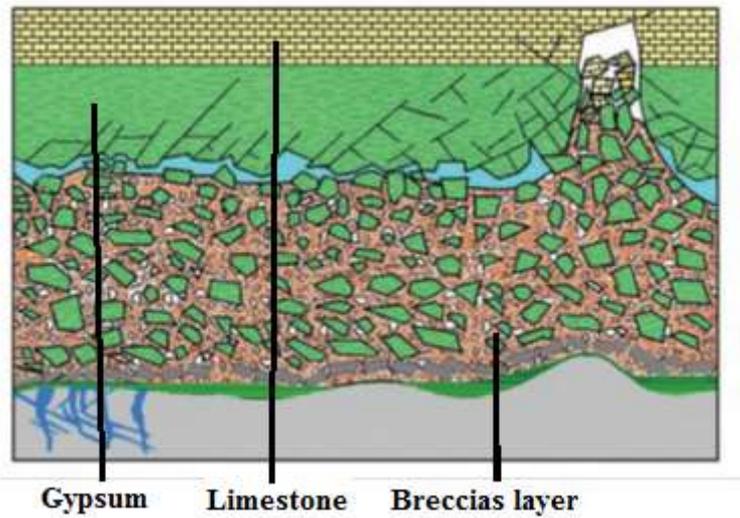
Figure 14: Schematic diagram showing the formation of a breccias layer

In Figure (14) the schematic diagram shown explains the process of the gypsum/breccias layer formation. Groundwater flowing through cavernous limestone and gypsum beds had resulted in the development of larger cavities in these limestone and gypsum beds, causing the collapsing in of gypsum, limestone and clayey marls filling these cavities and so forming a complex structure mainly of clayey material of very fine particles in which gypsum bits and particles and anhydrites blocks and even limestone flakes are embedded. These breccias layers due to their structure did not accept normal cement grouts or chemical grouts and many areas in the grout curtain within these layers could not be sealed and even

opened again under increased hydrostatic pressure which caused piping of the fine particles.

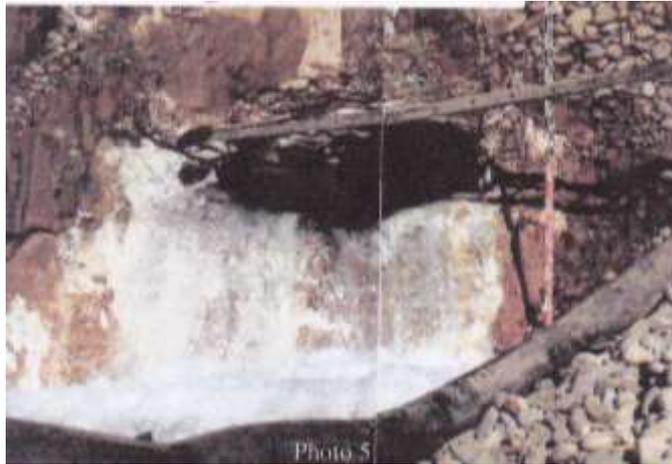
Similar seepage springs were encountered in the excavation of the tailrace tunnel and its intake structure. Grouting of these springs required extensive grouting works, and the continuation of the tunnel excavation was only possible after grouting the excavated face stage after stage. The quality of seepage water was much different from the river water quality and it contained a much higher concentration of Sulfates. Further studies showed that this water belonged to the very large Wadi Malih aquifer which is being fed from long distance upstream and which was running below and independent from the river aquifer. Figure (15) shows the water flow which was encountered during the excavation of the tunnel and which took considerable quantity of grouting until it was sealed works.

Figure 15: Flow (360 l/sec) from Underground aquifer into the intake/tailrace tunnel of the pump storage Scheme originating from Wadi Malih aquifer

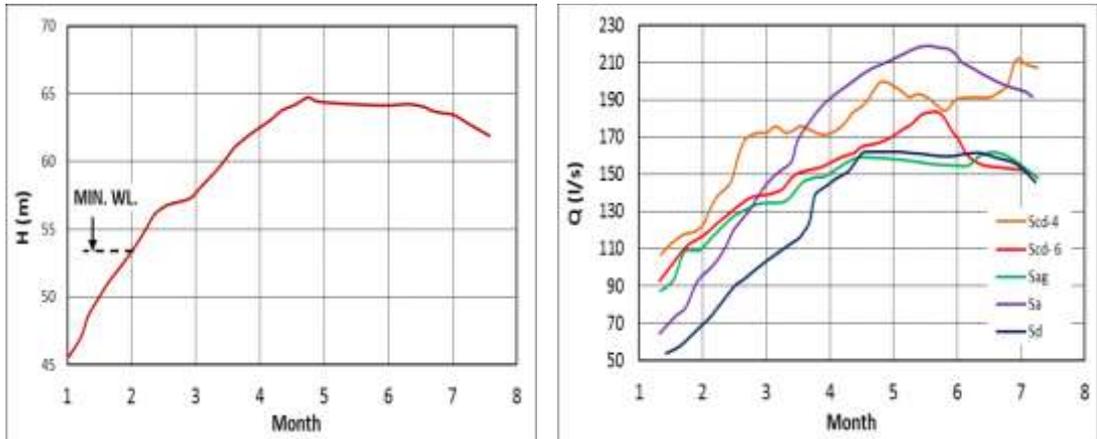
In winter 1986 as the reservoir level increased for the first time seepage began to appear from six major springs at the left bank downstream of the dam at different elevations along 1.5 km long stretch. Seepage also happened in the deep river section which was discovered from observing the increase of sulfate concentration in the water there. Indications of gypsum mineral leaching from the foundation rocks were evident which raised much concern then. Measurements and sampling of the seepage water were done on the left bank by collecting the water in channels and using weirs. The downstream coffer dam used during diversion was raised and fitted with a measuring weir so to measure and sample the seepage from the deep river section. Water samples were taken at two weeks interval and analyzed for their mineral content to establish the quantities of gypsum and other minerals being leached from the foundations. Results of seepage surveillance from February 10, 1986 to August 16, showed that the recorded seepage through the Main dam foundations and the left bank increased from 500 l/s to 1400 l/s in which water head had increased from 49 m to 65 m .Springs (Sa) and (Sd) in the left bank alone had increased from 150 l/s to 900 l/s (figure 16).The submerged springs at the river channel showed an increased transmissibility by 40% during the same period (from 630 m³/day to 880 m³/day) [17].

Figure 16: Left, reservoir water level increase Right, spring discharge variation
(for the period February-August, 1986)

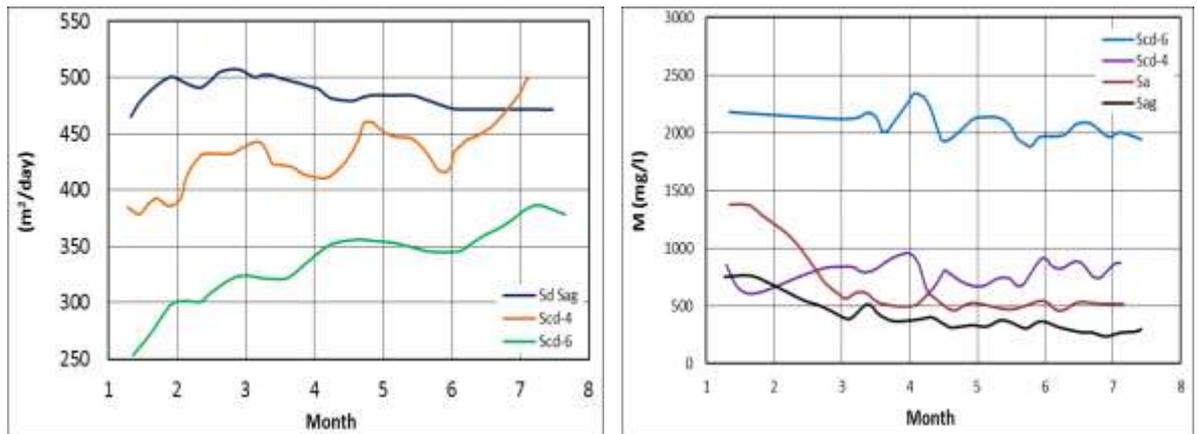
Figure17: Left: Spring transmissibility Right: Soluble salt concentration
for the period February-August, 1986.

Dissolution quantities of minerals from Dam foundations were established from the difference in the content of dissolved minerals in seepage water in relation to its content in the reservoir water (amounting to 250 mg/l as average). The total mineral contents of the seepage water by individual spring zones are presented in figure (17). Analysis of these results yielded that 13 000 tons of minerals were leached from the dam foundations at this period and that 70% of this quantity originates from the submerged springs. The dissolution intensity ranged from 42 to 80t /day.

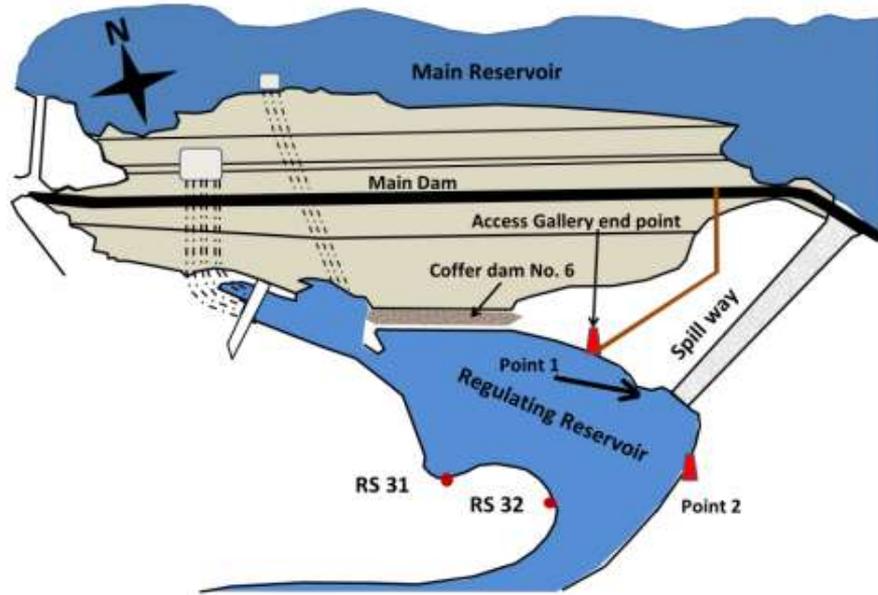
- a) Point (1), in the right side of the spillway at the end of the collection channel which collects seepage water from under the spillway that seems to originate from left side.
- b) Point (2), at left side of the spillway collects seepage water from under the dam further left and around the left side.
- c) Access Gallery end point collects seepages from under main dam from the river section to the spillway.
- d) Cofferdam no.6 measuring pond measuring seepage under the deep section of dam.

Figure 16: Seepage water Collection Points at Left Bank and cofferdam no.6
Measuring point [18]

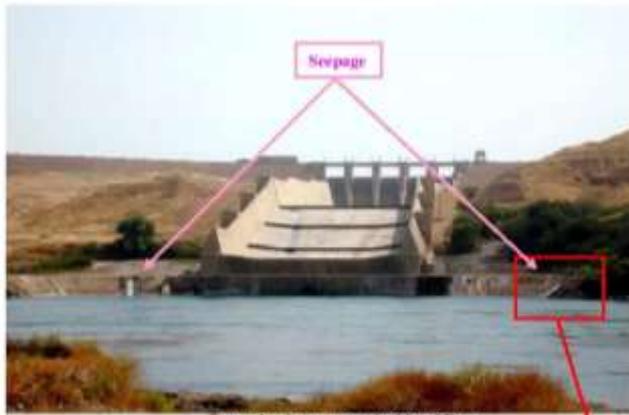
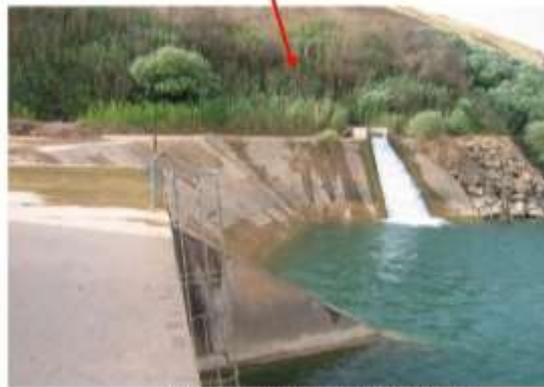
Figure 17: Seepage at the left bank (courtesy USACE)

Example of seepage at the Mosul Dam

Close-up view of seepage at the Mosul Dam

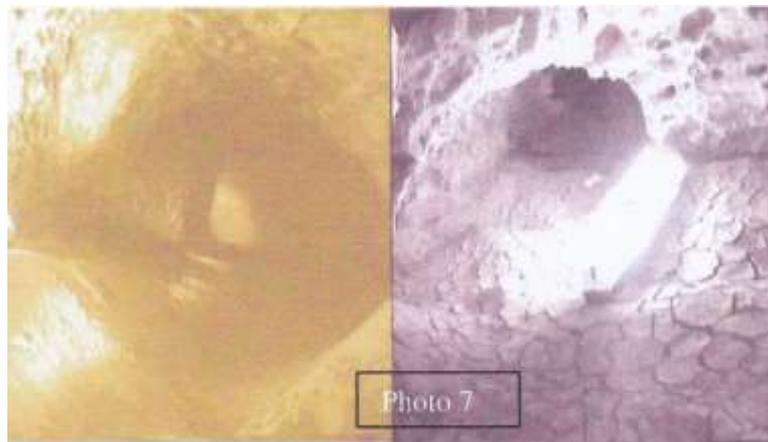
Figure 18: Large conduit found in March 2002 in the upper right rim of the reservoir

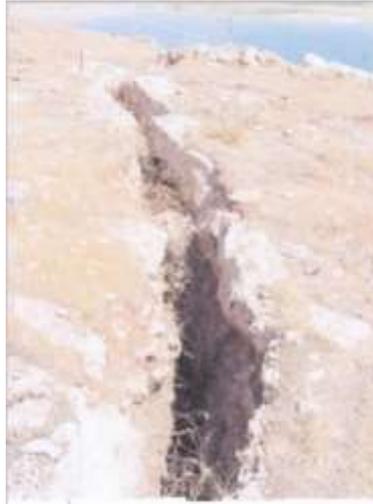
In figure (19) a ground fissure only 100m from the right abutment of the dam was also observed which was most probably caused by dissolution of gypsum layer at some depth resulting in a slide movement towards the reservoir.

Figure 19: Open fissure indicating slide slab movement at close proximity to right abutment resulting from underground dissolution.

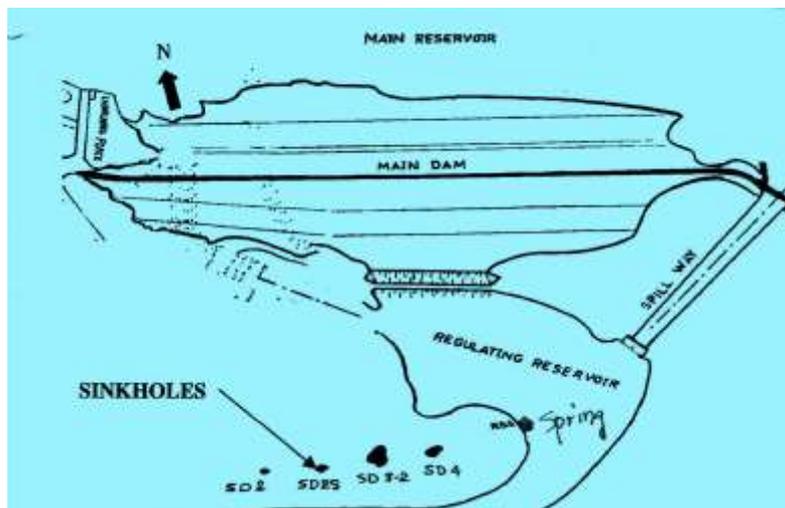
During the operation years of the reservoir, sinkholes developed downstream of the dam, and were observed on the right bank about 900 m downstream of the toe of the main embankment. Four sinkholes appeared in a linear arrangement in the period from 1992 to 1998 as shown in figure (20). These are SD2, SD2S, SD3-2 and SD4 (the largest).

Figure 20: Sinkholes downstream Mosul Dam-Right Bank

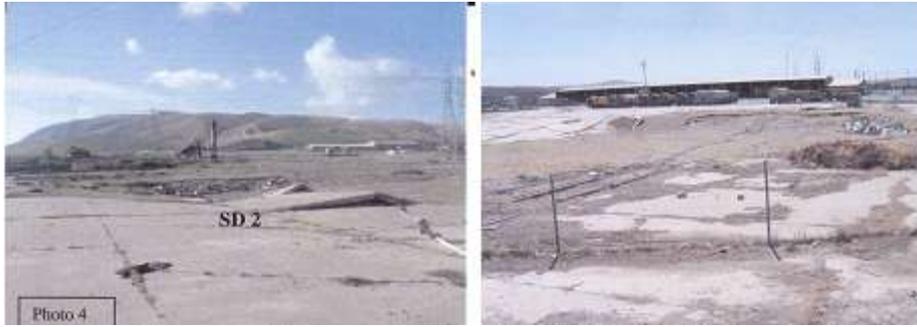
Figure 21: shows Sinkhole SD2 in the contractor paved yard before cleaning and after cleaning of these sinkholes.

The development of these sinkholes seems to be connected to the dissolution of gypsum in the underground layers due to the activity of Wadi Al malih aquifer on one side and the fluctuation of the tailrace water level resulting from the operation of the re-regulating dam downstream on the other side. The same dynamics was believed to be responsible for the appearance of water spring which was discovered after the washing away of terrace material by water discharging from the spillway at the opposite side of the river. The spring was on the same line of the sinkholes and its water had the same chemical contents of the sinkholes and the aquifer. Figure (22) shows the flow net of ground water flow towards the sinkhole and the discharge of this water into the river.

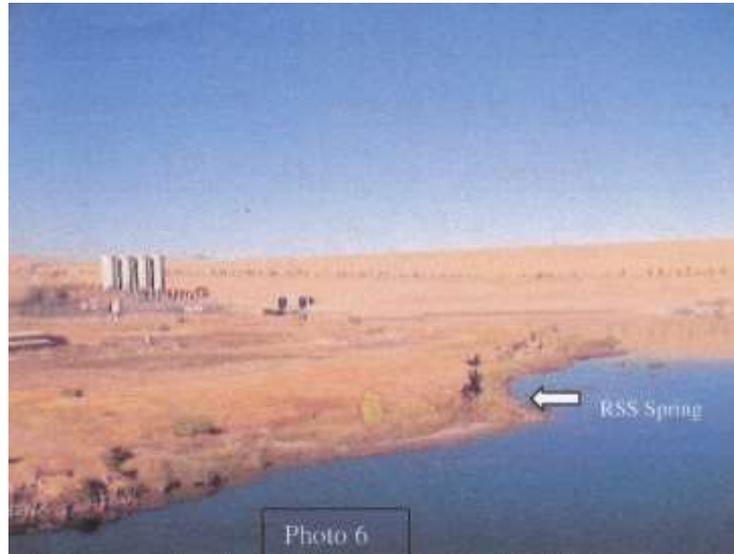
Figure 23: Spring on the right bank downstream of dam.

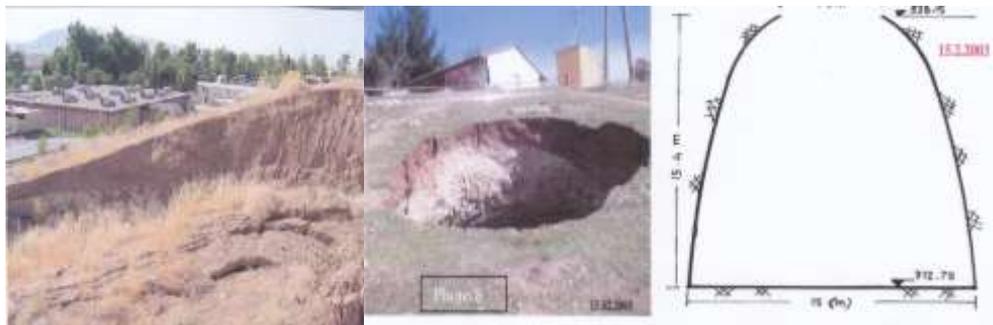
The formation of sinkholes was not limited to the right bank. In February 2002 one large sinkhole suddenly formed by the collapse of ground surface at a point only 150 m downstream of the dam toe at the left bank. It had a depth of 15 m and a diameter of 15 m as shown in figure (24). It was believed that its formation was due to seepage from under the left embankment somewhere along the axis causing the formation of big cavity in gypsum layer. The sudden collapse of the roof into this cavity was due to the infiltration of drainage water from nearby workers camp.

Figure 24: Left: Sinkhole before removing the collapsed material .Middle: After Cleaning: Right: sinkhole sketch showing dimensions.

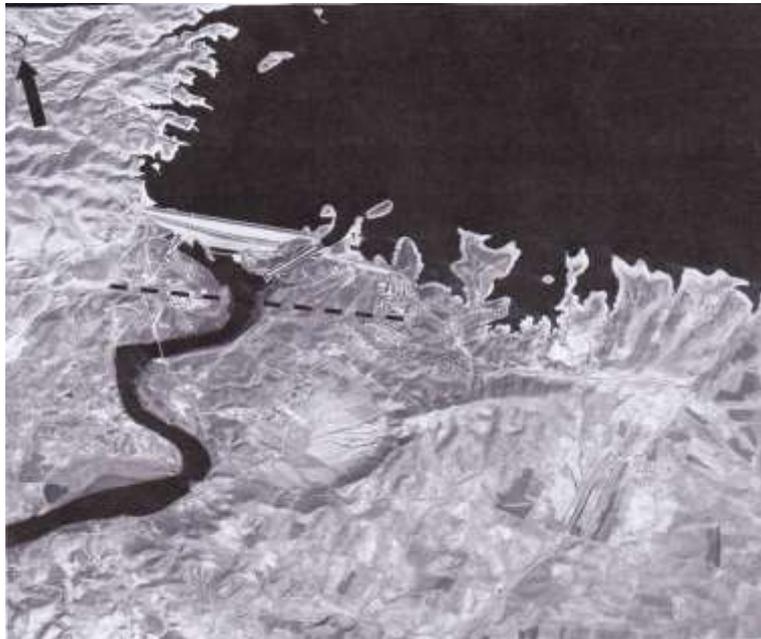
All these sinkhole seem to have formed in the same alignment on both banks as shown in figure (25), which may indicate the continuity of some geological feature.

Figure 25: Aerial view of the Dam area showing alignment of Sinkholes.

As a protection measure the maximum operation water level of the reservoir was limited to El 319 instead of El 330 in 2006. It must be mentioned also that this new level was not based on any concrete evidence to justify it, only that it may relax the situation somehow. The decision was taken on the understanding that it should be reviewed if further evidence is obtained in the future, but this has not been done so far.
