Mosul Dam the Full Story: Engineering Problems

Nasrat Adamo¹ and Nadhir Al-Ansari²

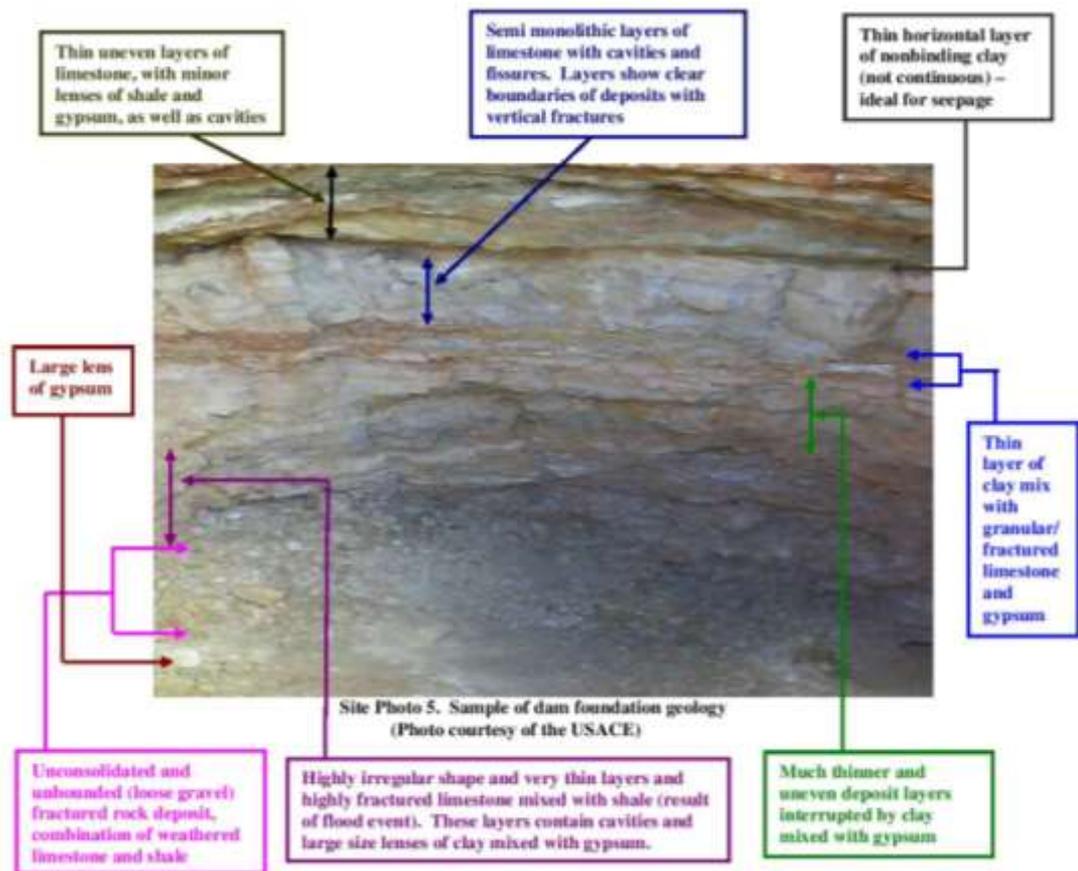
Figure 10: Foundation layers in Mosul Dam foundation
(courtesy of USACE)

The existence of highly karstified and jointed limestone layers in the dam foundations gave rise to the formation of highly developed conduits and caverns which form easy conduits to the flow of ground water. This had resulted in the extensive dissolution of gypsum and gypsum anhydrite rocks present above and below these limestone layers. These dynamics caused the collapsing of whole layers of clayey marls into the underneath cavities forming beds composed of brecciated gypsum particles and anhydrite blocks embedded into a loose clayey matrix. Four such layers were discovered during the geological investigations and

were called the (Gypsum-Breccias) layers. These layers had thickness which ranged between (8) meters and (16) meters. The first layer was found at a depth of (80) meters in the river section and it was marked as the (GB0) layer. The other three layers were at higher levels. The last one i.e. the (GB3) was discovered at the foundation of spillway chute ski jump. The (GB) layers proved to be very important due to their erratic behavior during the grouting of the deep grout curtain under the dam. Figure (11) shows the geological cross section under the dam. Figure (12) gives the litho-logical column under the Mosul Dam central part.

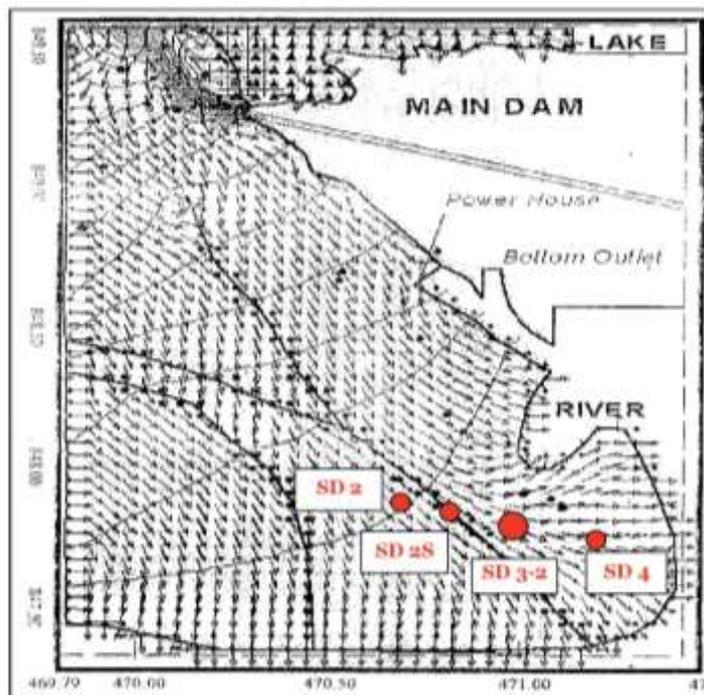
Figure 22: Flow net of ground water flow towards sinkholes

The development of these sinkholes seems to be connected to the dissolution of gypsum in the underground layers due to the activity of Wadi Al malih aquifer on one side and the fluctuation of the tailrace water level resulting from the operation of the re-regulating dam downstream on the other side. The same dynamics was believed to be responsible for the appearance of water spring which was discovered after the washing away of terrace material by water discharging from the spillway at the opposite side of the river. The spring was on the same line of the sinkholes and its water had the same chemical contents of the sinkholes and the aquifer. Figure (22) shows the flow net of ground water flow towards the sinkhole and the discharge of this water into the river.
